## PLUGGABLE BUS BAR IN-LINE MOUNTING 300A CONNECTOR

Testing was performed on Pluggable bus bar in-line mounting 300A connector to determine its conformance to the requirements of product specification 108-128012.

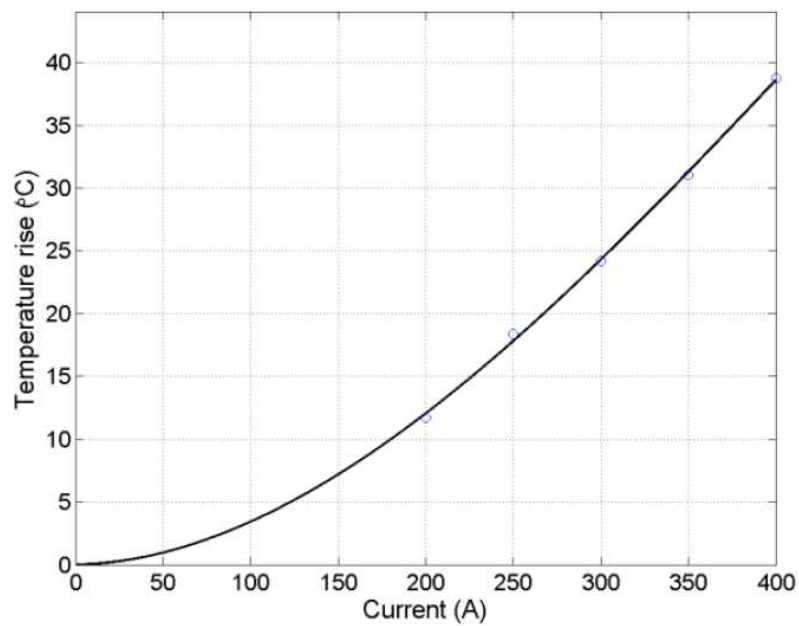
Graphs 1 Temperature rise vs current.

All assemblies had a temperature rise of less than 30°C above ambient when a specified current of 300 amperes current was applied. Detailed T-rise graphs in Appendix 1 (The graphs have been curve fitted from the actual data).

Specimens were subjected to temperature rise vs. current test in accordance with EIA-364-70, Method II. Assembly temperature was measured, while energized at the specified current. Thermocouples were attached to the connectors to measure their temperatures. This temperature was when subtracted from the ambient temperature to find the temperature rise. When three readings at five minute intervals were within 1 °C, the reading were recorded.
